**Final Report**

**Effect of Damage Processes on Spallation Life in Thermal Barrier Coatings**

*(AFOSR Grant # F49620-98-1-0390 ; Program Monitor – Dr. H. Thomas Hahn)*

**Golam Newaz (PI)  
Professor of Mechanical Engineering  
5050 Anthony Wayne Drive  
Wayne State University  
Detroit, Michigan 48202**

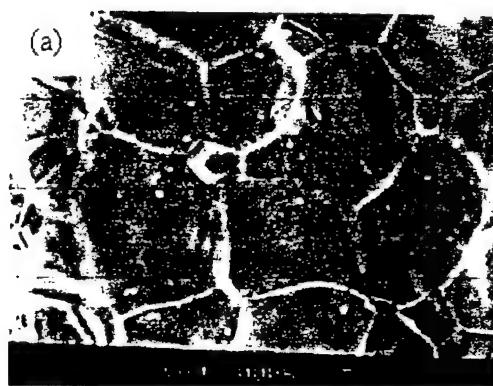
Figure 6.12 shows the damage evolution in oxide layer with increased thermal cycles  
(a) 0 cycle; (b) 25 cycles (c) 75 cycles; (d) 150 cycles.

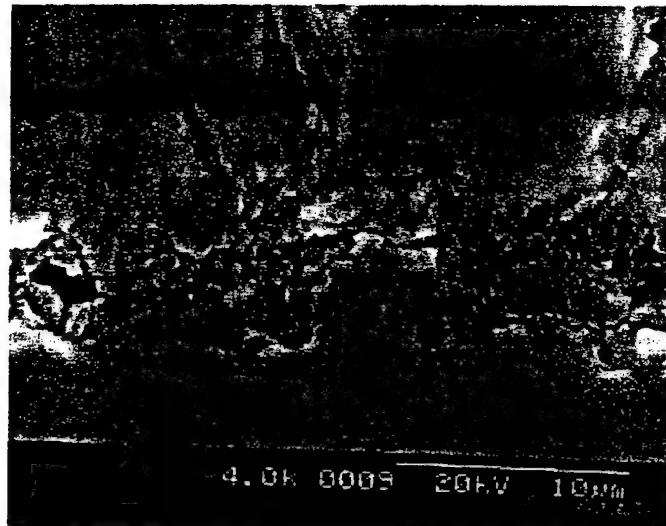
The Figures 7.6 and 7.7 show the comparison of microstructures of the cross-section of 50 B cycles in air and 50 B cycles in air plus 340 B cycles in vacuum. The thickness of TGO in both specimens was the same. However, there were voids and microcracks (Figure 7.6) in TGO or at interfaces before vacuum heat treatment, while TGO shows a high-density layer, few voids or microcracks could be found in TGO layer and interfaces. The figure 7.7 shows the crack where the TGO/bond coat interface had been partially healed. The alumina did not lose its adhesion to the bond coat even after

The bond of both interfaces (TBC/TGO and TGO/bond coat) was improved by vacuum heat treatment. Most interfacial damages were healed during vacuum heat treatment. Figure 7.6 shows an interfacial crack where the TGO/bond coat had been partially healed. As per the binary phase diagram of  $ZrO_2$ - $Al_2O_3$ ,  $ZrO_2$  solid solution can be formed up to & mol%  $Al_2O_3$  even at  $1885^{\circ}C$  (Smyser, et al., 1996). Schilbe (2000) studied substrate alloy element diffusion in thermal barrier coatings. It was proposed that the increase of contact time between TBC and bond coat by TGO could result in the increase of intermixing or solid solutioning in TBC/TGO interface. Brickey and Lee (2000) investigated the microstructure of TBC/TGO interface in thermal barrier coatings

Figure 7.6 shows there were many voids and microcracks in TGO and interfaces after 50 cycles in air at thermal test B.
